**US ARMY
AVIATION
SYSTEMS COMMAND**

**FULL-SCALE CRASH TEST (T-41) OF THE YAH-63 ATTACK
HELICOPTER**

Kent F. Smith

April 1986

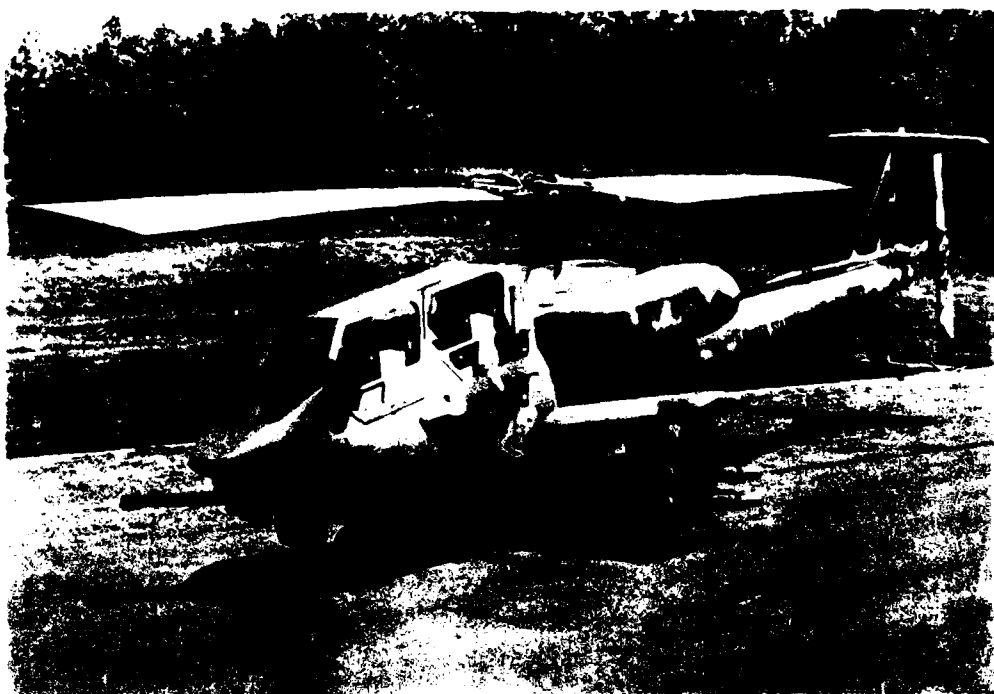
Figure 1. YAH-63 attack helicopter.

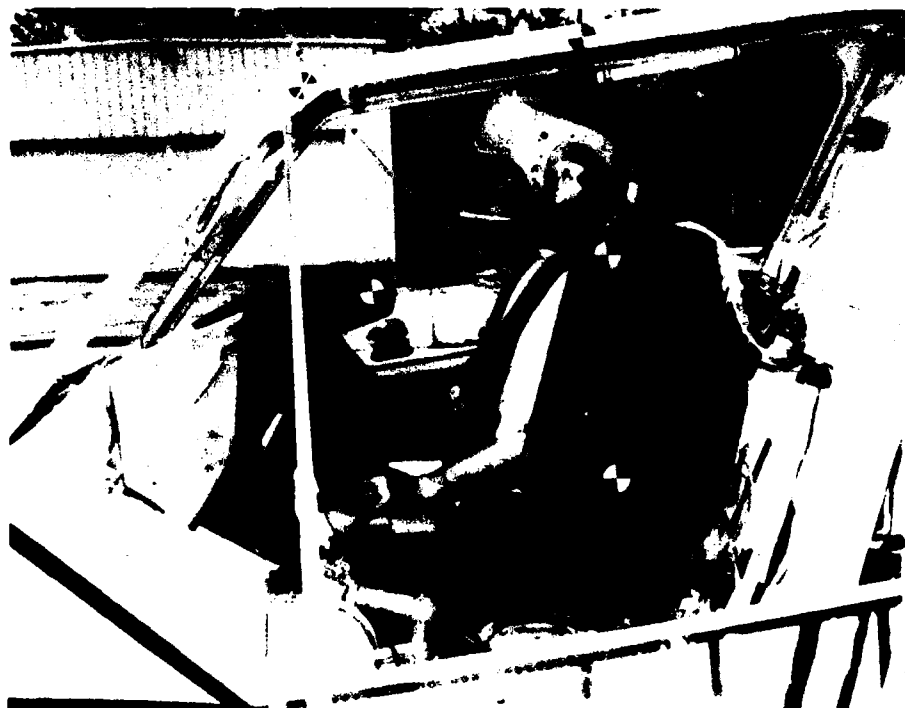
Figure 6. T-41 test installation at CPG crew station.

The YAH-63 forward CPG cockpit was modified in a manner so as to more closely represent that of an AH-64 Apache copilot/gunner (forward) cockpit. Figure 6 shows the test configuration for this crew station. The standard YAH-63 crew seat was removed and replaced with a production AH-64 crashworthy crew seat (Figure 7). The seat is bulkhead mounted and armored with boron carbide tile bonded to laminated Kevlar and has a total weight of 136.6 pounds, including cushions and restraint system. The armored bucket is designed to stroke up to 12.3 inches in the vertical direction to absorb crash impact loads using two inversion tube energy attenuators. The fixed-load attenuators are sized for a 14.5 G stroking load based on the weight of an equipped 50th percentile Army aviator. The bucket is supported by roller bearings engaging steel guide tubes to restrict its stroking to the vertical direction only. This is very important in limiting the aviator's forward/lateral strike envelope within the cramped confines of the AH-64 cockpit. This seat was designed to meet the requirements of the Army's crashworthy crew seat specification, MIL-S-58095(AV) (Reference 4).

The AH-64 incorporates a weapon's sighting device termed an optical relay tube (ORT) in the forward cockpit. Figure 10 is a photo of the actual AH-64 installation. The close proximity of the ORT to the CPG places it within the potential head and upper torso strike envelope of this crewman. A dummy ORT, constructed of lightweight styrofoam, was fabricated and sized to the overall ORT dimensions. It was mounted in the forward YAH-63 cockpit at the same relative distance from the seat reference point as found in the AH-64. The intent of the dummy ORT was twofold: (1) to determine whether or not the CPG restrained with an IBAHRS would contact the ORT in a 95th percentile potentially survivable crash, and (2) if contact was made, to establish, through high-speed photography, the approximate relative striking velocity. The test installation of the dummy ORT is shown in Figure 6.

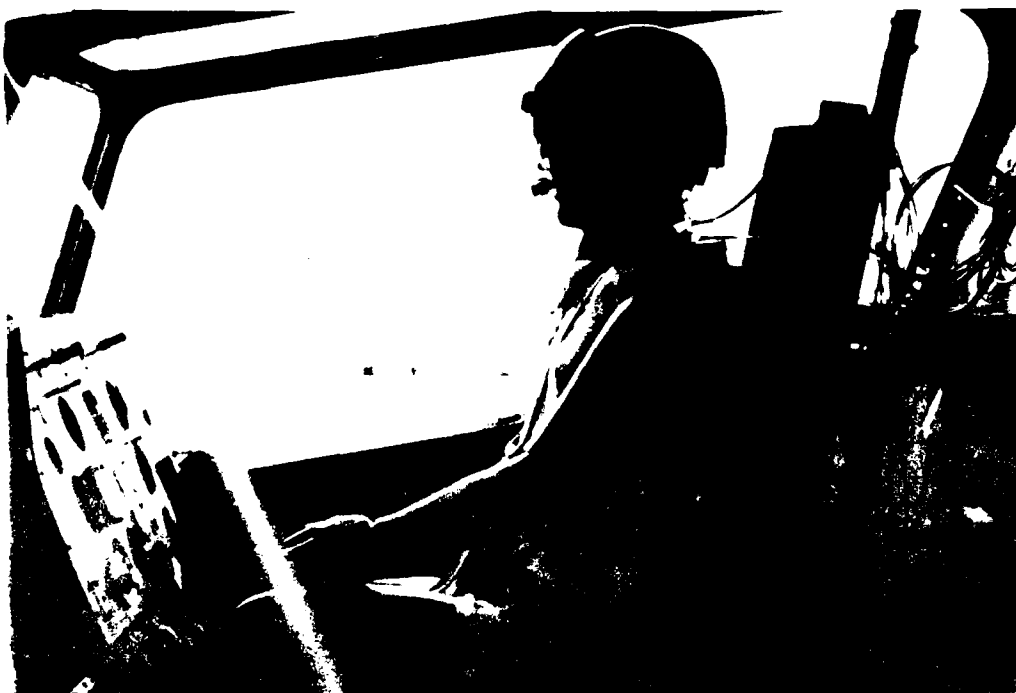
Figure 12. T-41 pilot (aft) cockpit test installation.

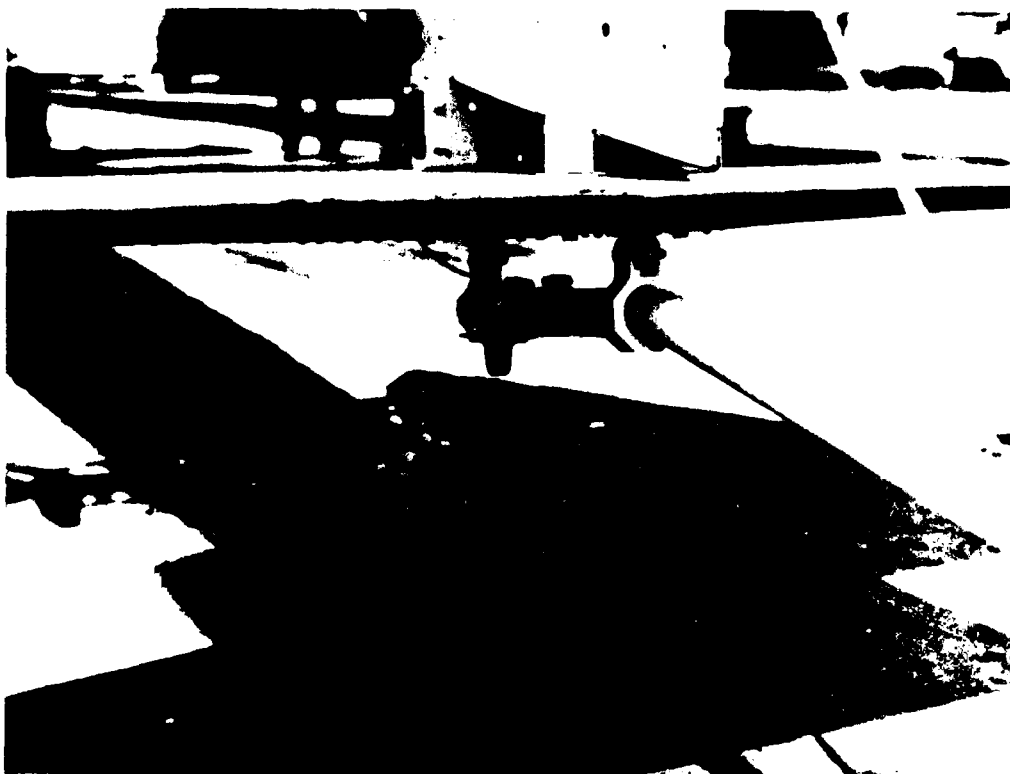
Figure 14. Tail-skid-mounted frangible trigger switch for deploying FIR/CPL.

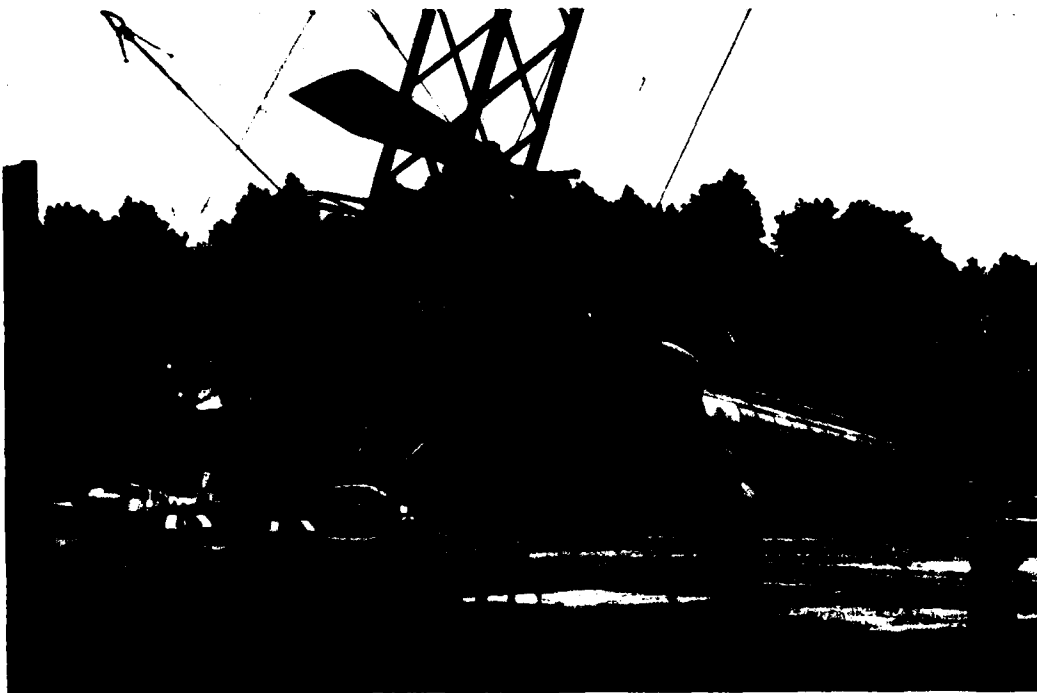
Figure 22. YAH-63 in preimpact attitude
